Slope stabilization  
with a steep inclination

Stabilization of slopes

## Stabilization of slopes and establishment of vegetation cover on rocky slopes, in area which is prone to hurricanes.

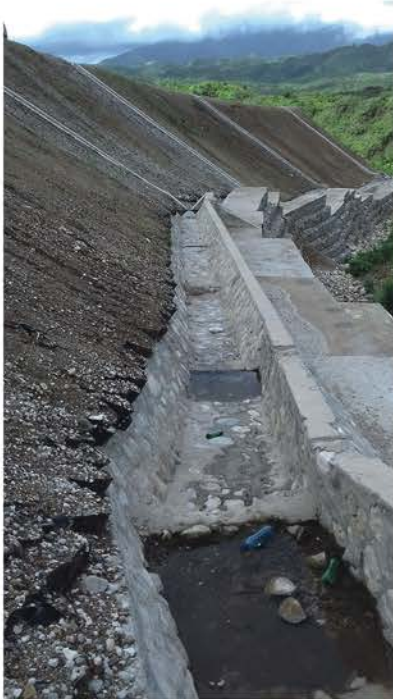
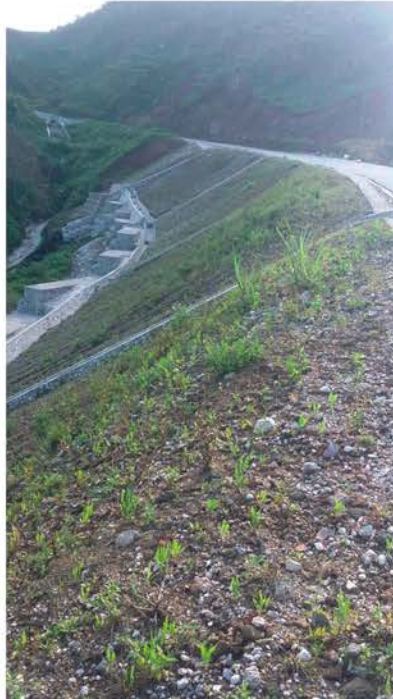
The solution was to install a layer of GeoGlobe® geocells above the slopes, and to achieve a stable solution for confinement of the soil.

The GeoGlobe® geocells were fixed at the top and expanded downwards very slowly, due to the steep slopes. After all the geocells were expanded and anchored, they were filled with vegetated soil.

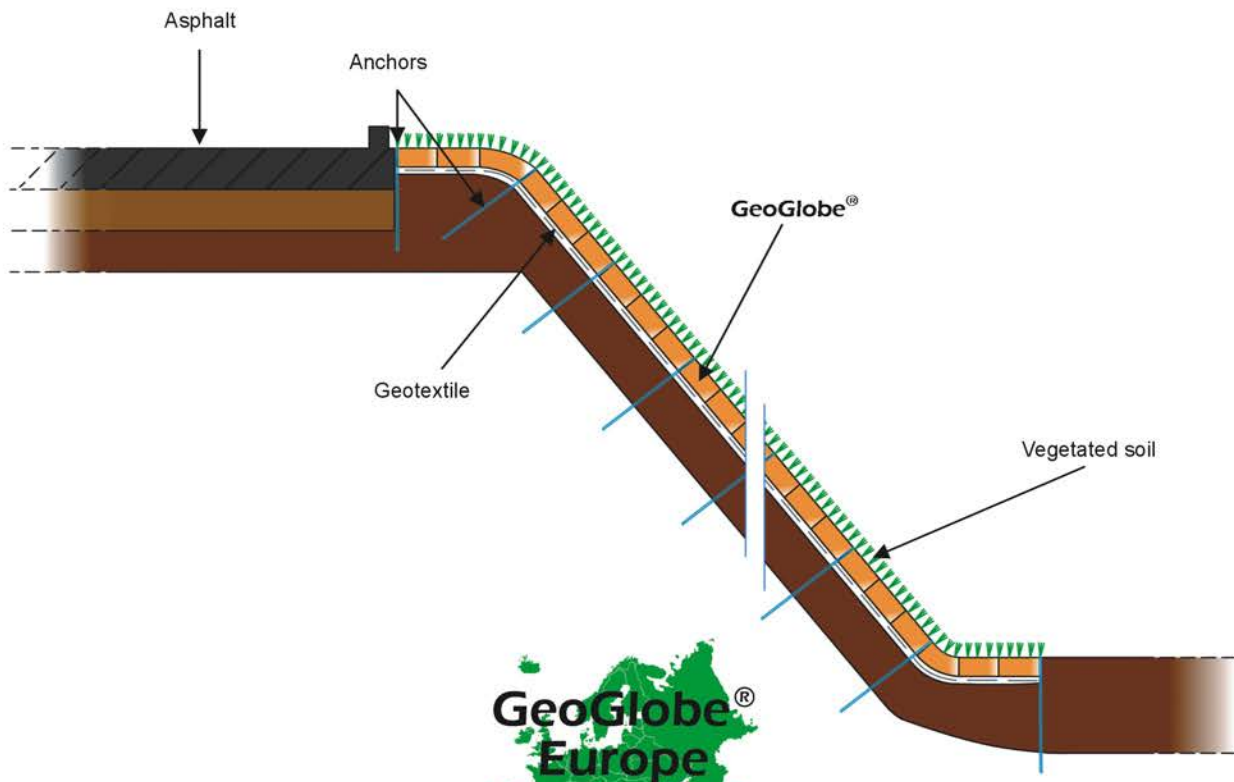
The slopes were perfectly protected against the sliding of the soil. The installation was done within a short period. After two months the area was under heavy rain due to a hurricane, but no damage to the slope, the geocells, or the infill occurred. After a very short period the vegetation had begun to grow inside the GeoGlobe® geocells.
