Hydraulic erosion control and drainage

Flood prevention and road safety

Deviation of a watercourse causing flood near a highway

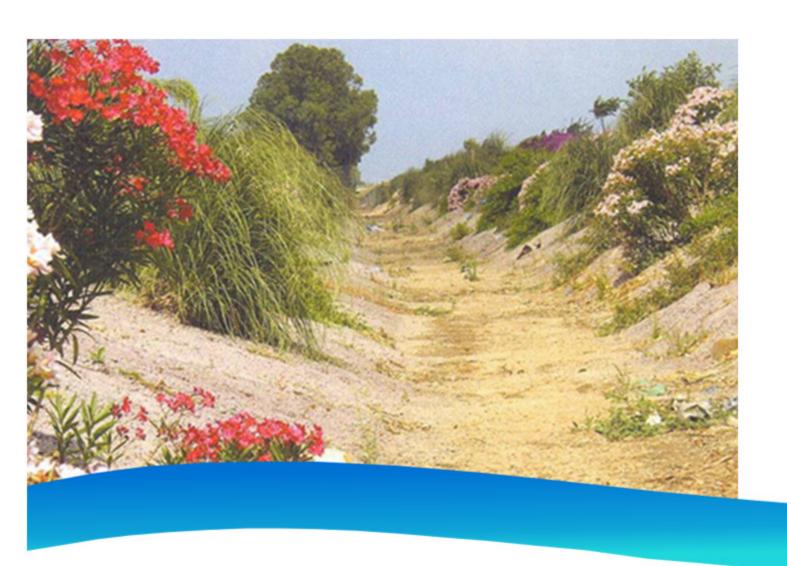
- The rainwater is concentrated in a watercourse located near a highway down-stream of a mountain, suddenly rising the water level from 0 to 3 meters.
- This high flow is caused by the infiltration and the water erosion under the road parallel to the watercourse.
- The waste is accumulated in the watercourse and thus frequently blocking it up.
- Seasonally, heavy rains inundate all neighboring terrains.

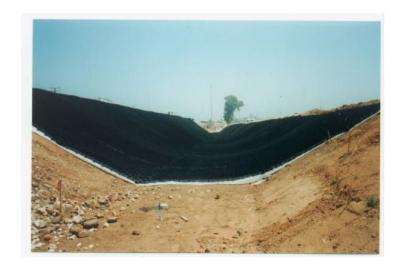
In order to solve the flood problems the channel- bed of the watercourse can be deverted and reinforced with the help of GeoGlobe® filled with concrete with brown pigment. Planting trees and bushes to harmonize the channel with the surrounding landscape in the heart of a natural park.

After cleaning and shaping the channel-bed of the watercourse GeoGlobe® is expanded and anchored to the width over a nonwoven geotextile. After that the cells are filled with concrete with brown pigment reserving some cells for plantations.

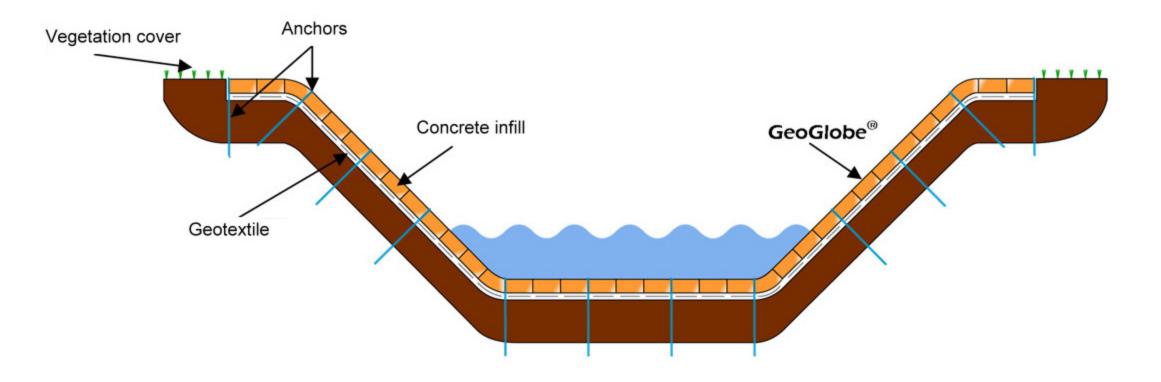
The watercourse flows regularly for over 10 years, collects the run-off from upstream to go into the sea.

Due to the vegetation that covered the banks, it is almost impossible to discern the concrete.

After the reinforcement of the bed of the watercourse, it is possible to pass a tractor to clean it easily. Because of the construction of the channel with a confinement system, there are no more floods on the neighboring terrains and the road is not damaged anymore by the erosion caused by the water infiltration.
